Manhole Inspection Summary

Manhole # S23A__029MH

Insp Date: **7/27/07 7:51 AM**

Location Address: **630 VINCENT-GILMORE**

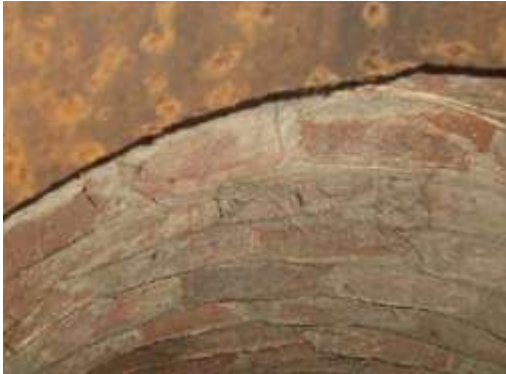
Defect 3

Condition: ☐ Sound ☒ **Cracked** ☒ **Root Intrusion** ☐ Loose Brick ☐ Deteriorated

MAJOR CRACK IN CORBEL (DOES NOT SHOW UP THAT WELL WITH PICTURE)

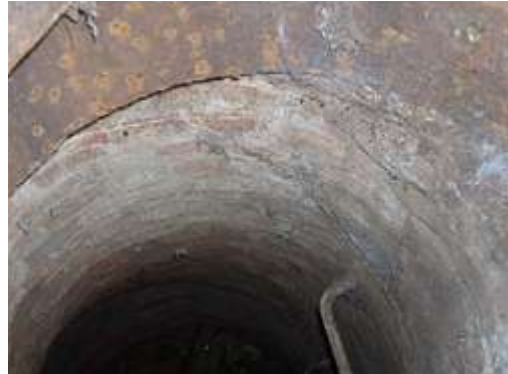
Defect 2

Infiltration: ☐ None ☐ Joint ☐ Cracks ☐ Mortar ☒ **Roots** ☐ Wall

ROOT INTRUSION OF CORBEL

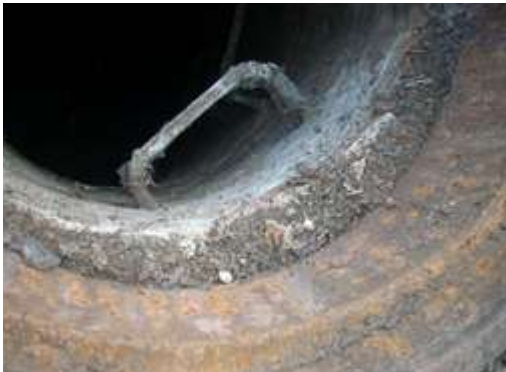
Defect 1

Frame Offset: **3** (in.) Condition: ☒ Sound ☐ Cracked ☐ Leaks

FRAME OFFSET AND CORRODED STEPS

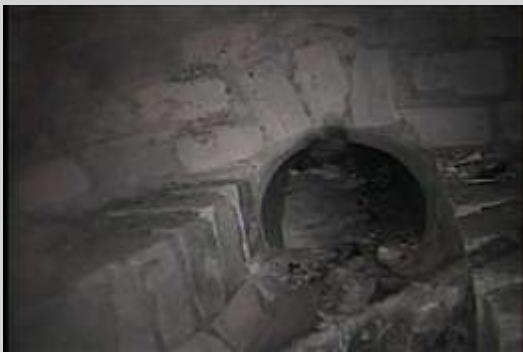
12 O'Clock Outflow

Pipe Height: **7.2** (in.) Rod and Bar (Angled)
Pipe Material: **Clay** ☐ Pipe Lined
Invert Depth: **10.52** (ft.) Flow Characteristics: **Slow**
Deposits: ☐ None ☒ **Mud** ☐ Sludge ☐ Debris ☐ Grease
Silt Depth: **2** (in.) Deposits Extent: **Light**
Infiltration: **None** Pipe Seal Cond: **Sound**

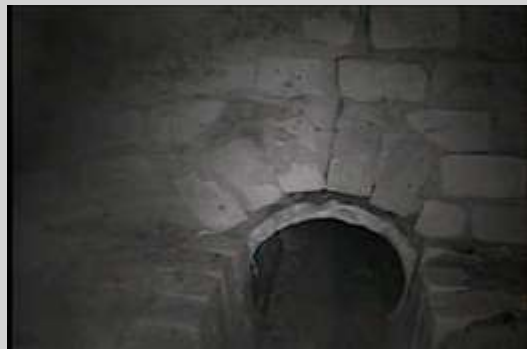
9 O'Clock Inflow

Infiltration: **None** Pipe Seal Cond: **Broken**
